NO.	SCOPE OF WORKS	REMARKS
1	INSTALLATION OF METAL SUPPORTS OR CABLE TRAY FOR PLANT 2- PHASE A, PLANT 3- PHASE A & PHASE C, PLANT 4- PHASE C	AS PER RECOMMENDATION OF WESTCO, CORRECTIVE ACTION (FEB 2024) UPON PMS FINDINGS (CONDUCTED BY FUJI HAYA OCT 2023)
2	REPLACEMENT OF CRACKED BUSHING FOR PLANT 3- PHASE A (X1)	AS PER RECOMMENDATION OF WESTCO, CORRECTIVE ACTION (FEB 2024) UPON PMS FINDINGS (CONDUCTED BY FUJI HAYA OCT 2023)

Findings and Observation

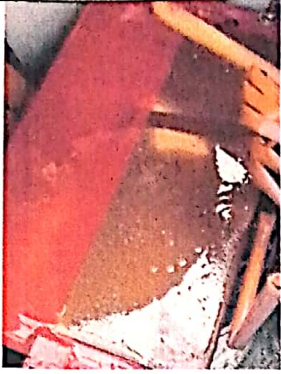
<p>Findings: Oil contaminants were found in the following transformers: Plant 1 Phase A, and C, Plant 2 Phase A, B, and C, Plant 3 Phase B, and Plant 4 Phase C.</p> <p>Action Taken: Oil flushing was performed before the replacement of transformer oil to eliminate the contaminants.</p>

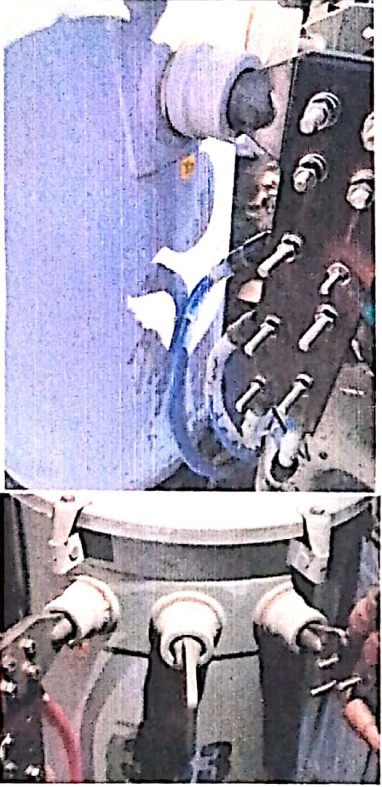
<p>Findings: Oil leakage was observed after disconnecting secondary terminals of the transformer. This could be due to the stress caused by the weight of the metal plates and cables.</p> <p>Action Taken: Regasketing was also performed in the secondary bushing of the transformer.</p> <p>For Plant 2 - Phase A, Plant 3 - Phase A & Phase C, Plant 4 - Phase C</p> <p>Recommendation: Installation of metal supports, or cable trays is recommended to support the weight of metal plates and cables.</p> <p><i>See image below for the initial proposed installation layout</i></p>

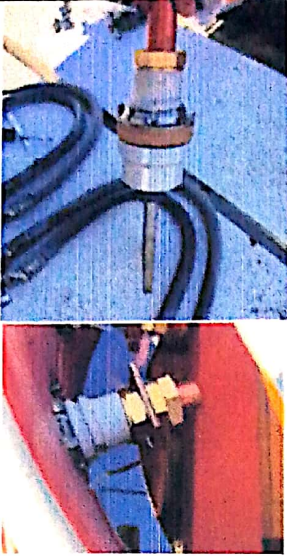
<p>Findings:</p> <p>Crack on secondary bushings was found on Plant 3 - Phase A(x1)</p> <p>Overall insulation power factor test can be done to further investigate the condition of the bushing. Otherwise, replacement of the cracked bushing is recommended.</p>

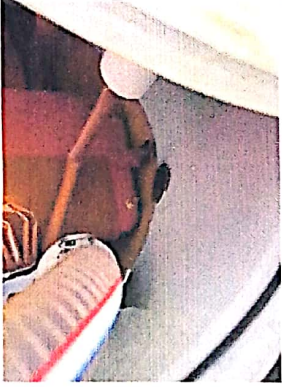
<p>Findings:</p> <p>Welding spot was found on Plant 1 - Phase C</p>
